Rehabilitation of an Incised Stream Using Plant Materials: the Dominance of Geomorphic Processes

*F. Douglas Shields, Jr.*¹, *S. Reza Pezeshki*², *Glen V. Wilson*¹, *Weiming Wu*³, and *Seth M. Dabney*¹

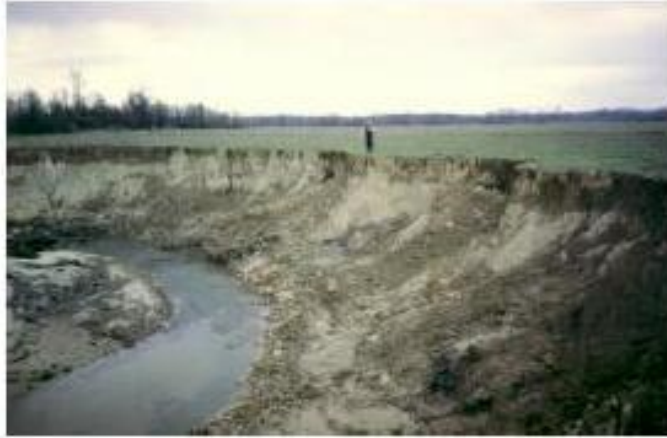
Inputs of sediment to the stream were sporadic because of the episodic nature of bank retreat, headcut advancement, and gully development (Fig. 3). Channel incision triggered the formation of approximately 30 riparian gullies along the study reach because concentrated flows of runoff or floodwaters that returned to the channel following an overbank event produced rapid erosion of the high banks (Dabney et al. 2004). Preliminary estimates suggest that gully erosion produced sediment at a rate equivalent to 42% of the sediment yield for the entire watershed containing the study site (Wilson et al. *unpublished data*). High banks were also sites for piping as a result of seepage erosion because subsurface flows as great as 0.9 m³/s with sediment concentrations as great as 660,000 mg/L emerged from individual pipes during rainy

Fig. 3. Physical instability along Little Topashaw Creek prior to rehabilitation. (A) Bank erosion, (B) headcut advancement, (C) riparian gully erosion.

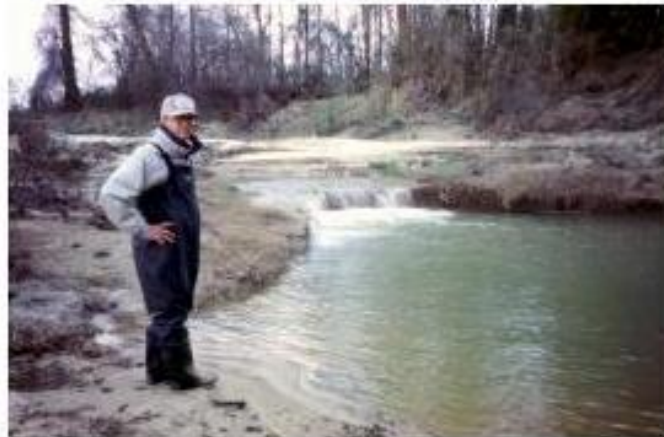
(B)

upstream headcuts (Wallerstein 2000). Headcuts (knickpoints) were found downstream, within the study reach, and upstream. Approximately 60 m of headward migration of a 0.6 m high headcut and bank retreat as great as 7.6 m were observed during a single storm event in the study reach. At least two abandoned meanders in the study reach suggested recent natural neck cutoffs. Concave banks on the outside of meander bends failed because of mass wasting, and sand accreted on large point bars opposite failing banks. Interestingly, several point bars were dissected during high flows, leaving large sand deposits along the toe of concave outer banks.

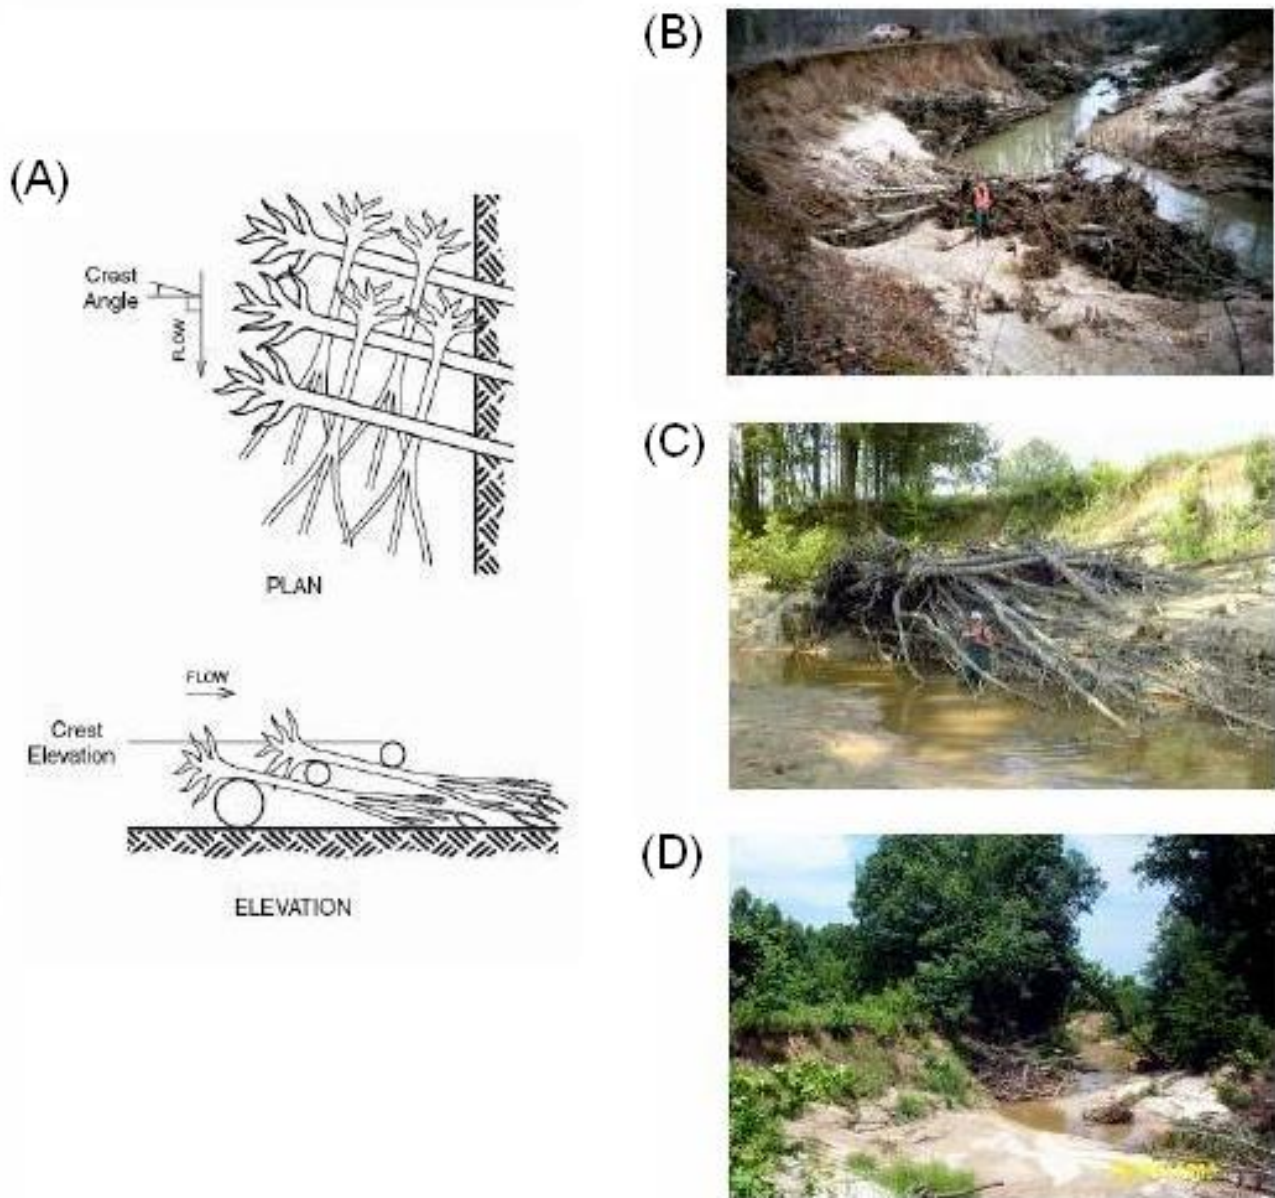
Fig. 4. A large wood (LW) structure deployed at Little Topashaw Creek. (A) Design plan and profile. (B) LW structure 5 months after construction; note sediment deposits within the structure. (C) The same structure in (B) 9 months after construction. (D) The same structure in (B) completely disappeared 3 yr after construction.

structures were destroyed and 35% were heavily damaged. Factors involved in failure included the simplification of LW matrices because of breakage and decay, scour of sediments deposited within the structures (Fig. 4B and C), and the failure of earth anchors (USDA 2006b). Structures that were located in sharp bends were most prone to fail. The damage rates were slightly higher for anchored LW structures (20 of 58 damaged) than for those without earth anchors (4 of 14 damaged). Of all anchors, 47% were located upon inspection 2 yr after construction, and 61% of these were not functional. Evidently, the anchors, which were load tested to 4.5 kN when installed, were undersized. The anchor sizing was based on LW structure design dimensions and the assumption that critical conditions would occur shortly after construction. Accordingly, a relatively high wood density of 750 kg/m^3 was used to compute net buoyant forces. Retrospective computations using as-built dimensions and a wood density of 450 kg/m^3 produced factors of safety well below unity.

For LW structure design, it was assumed that sediments deposited within the LW structure would add ballast to counteract the increased buoyant force associated with the drying of wood as the structure aged. A geomorphic assessment of the rehabilitation reach indicated that the period of channel deepening typical of incised channel evolution was ending; the natural tendency of the system favored the deposition of large sand berms within the enlarged, eroded channel. Initially, substantial volumes of sediment were captured by the LW structures (Fig. 4B). However, in many cases, sediments deposited during the first high flow season were scoured during the second, and approximately 0.3 m of thalweg degradation occurred throughout the reach.

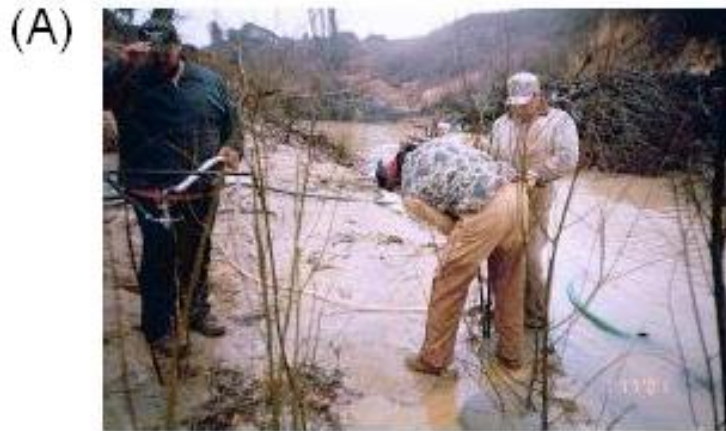
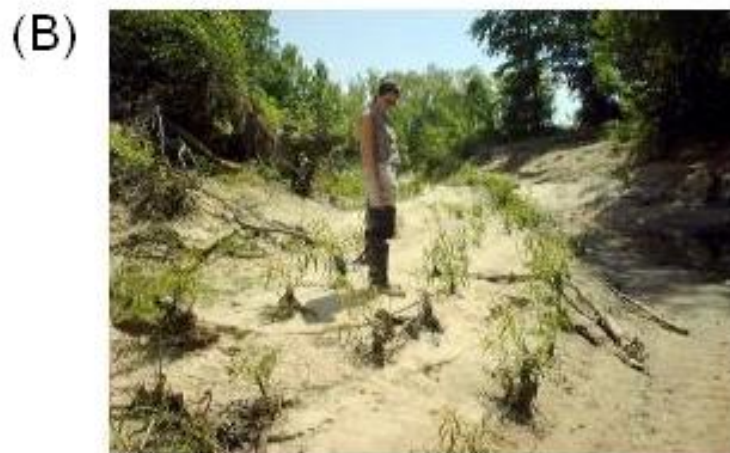
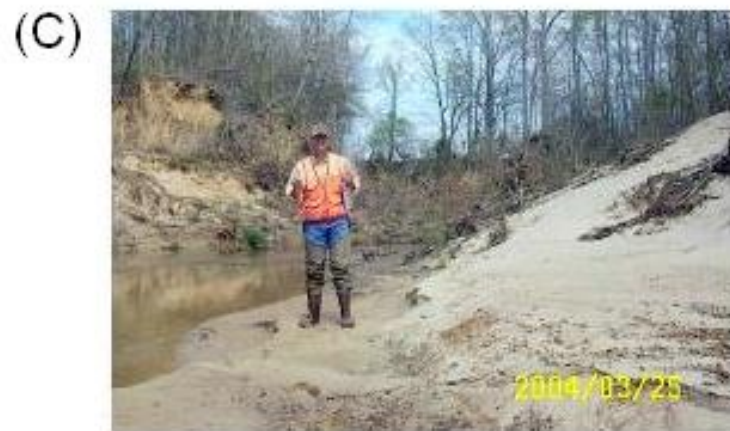
Fig. 5. Willow cuttings planted at Little Topashaw Creek. (A) Willows being planted using water jetting. (B) Initial willow stand 4 months after planting, showing effects of herbivory. (C) The same location in (B) 3 yr later, showing no survivors.

More than half of the monitored willows survived the first growing season and > 40% survived two seasons. However, a survey of all of the willow plantings at the beginning of the fourth growing season indicated that the survival rate was < 10% (Fig. 5B and C). Reasons for planting failure likely include erosion and sedimentation (channel stability), competition from exotics, and chronic herbivory by beaver (Pezeshki et al. 2007), although there were indications that limited, acute herbivory was not harmful (Li et al. 2005).

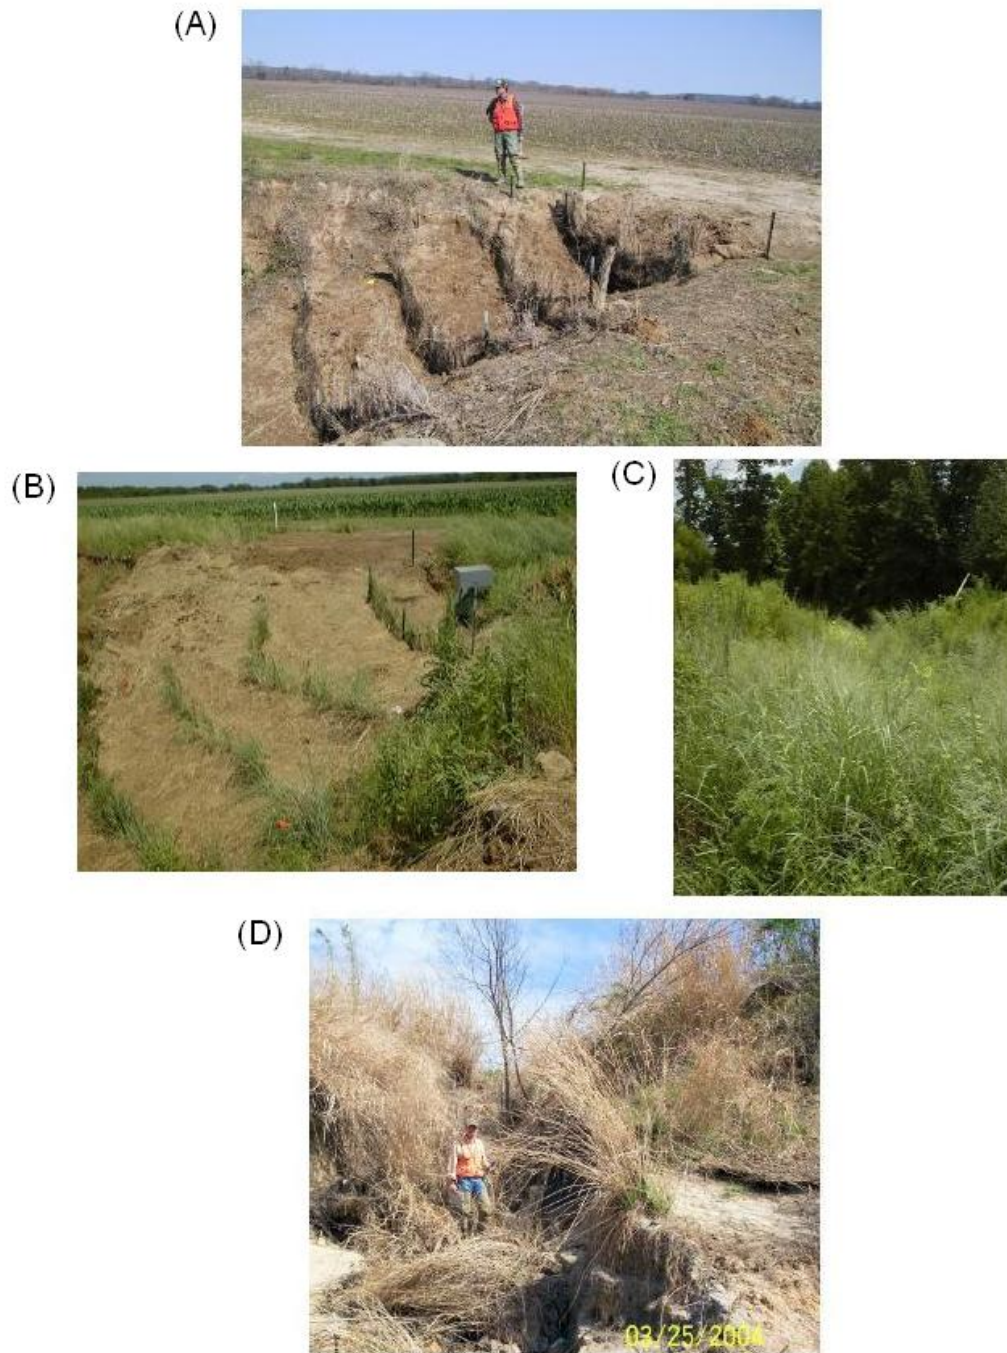
Fig. 6. Riparian gully stabilization using switchgrass hedges at Little Topashaw Creek. (A) Gully immediately after shaping and planting, showing silt fences placed just below each grass hedge. (B), (C) Development of grass during the first growing season. (D) View from the stream channel 3 yr after planting.

Although hedges were successfully established and effectively stabilized riparian gully side slopes (Fig. 6B and C), treated gullies were vulnerable to headcuts > 0.5 m high that advanced from the stream channel into the gully. Gully control with grass hedges failed in three modes (Dabney et al. 2004, Shields et al. 2005). The most immediate failure occurred at the gully toe, where sand bars up to 2 m deep either buried the hedges or did not provide a stable substrate for grass establishment. Large headcuts developed from the toe and progressed

upslope. The second mode of failure occurred when the gully slope was too steep to allow the formation of plunge pools between hedges, leading to direct impingement of cascading flows onto exposed bare soil surfaces (Dabney et al. 2004). This mode of failure was most common on unshaped inlets. The third and most troublesome failure mode was the gradual grain-by-grain soil detachment that eventually washed the soil away from the grass roots, leading to deep incision through the grass hedges. Visual inspection of all of the treated gullies during the sixth year after treatment showed that all

supported dense stands of switchgrass, but all were being dissected by headcuts 0.5 to 1 m high that advanced headward from the stream channel (Fig. 6D).

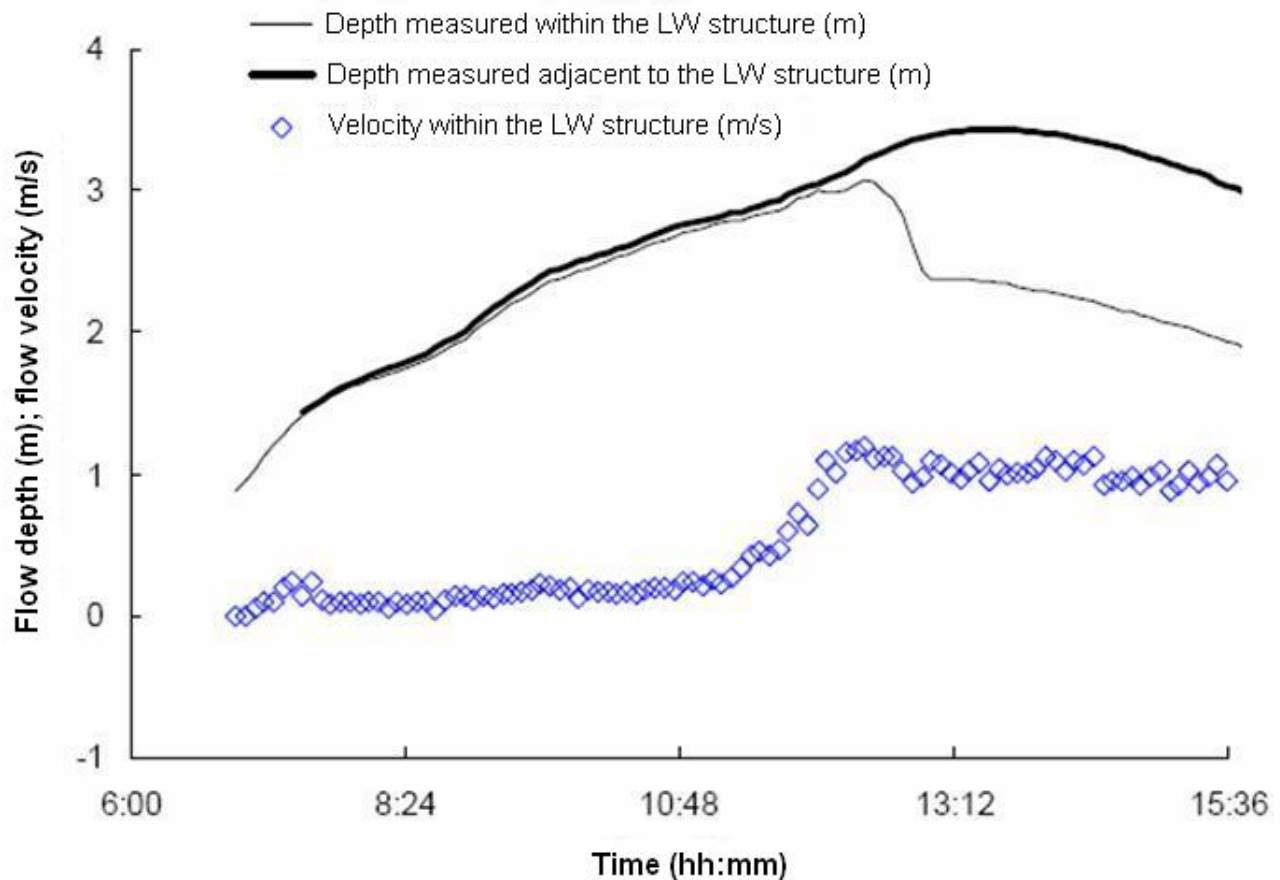
Typical failure processes are illustrated by detailed data from one LW structure. Acoustic Doppler velocity loggers recorded the depth and velocity within and adjacent to an LW structure located at the apex of a bend with a ratio of top width to bend radius of ~ 1.0 . During the rising limb of a large flow event that occurred approximately 16 months after construction, part of the structure apparently shifted, allowing velocities within the structure to increase rapidly from 0.2 to 1.2 m/s, greatly exceeding the critical level for the sandy bed material and approaching the velocity recorded at the adjacent channel centerline (Fig. 9). The structure failed shortly thereafter.

Fig. 9. Water depth measured at the channel centerline adjacent to a large wood (LW) structure during a storm event on Little Topashaw Creek and simultaneous measurements of water depth and velocity within the structure. The sudden drop in the curve representing water depth within the structure corresponds to dislodgement of the log to which the sensor was attached. Note the increase in current velocity just prior to the movement of the log.
